Inside Information Through Real Time Dynamic Structural Monitoring

Unique Method Allows Engineers to “See the Unseen” and Optimize Design

The Jetty

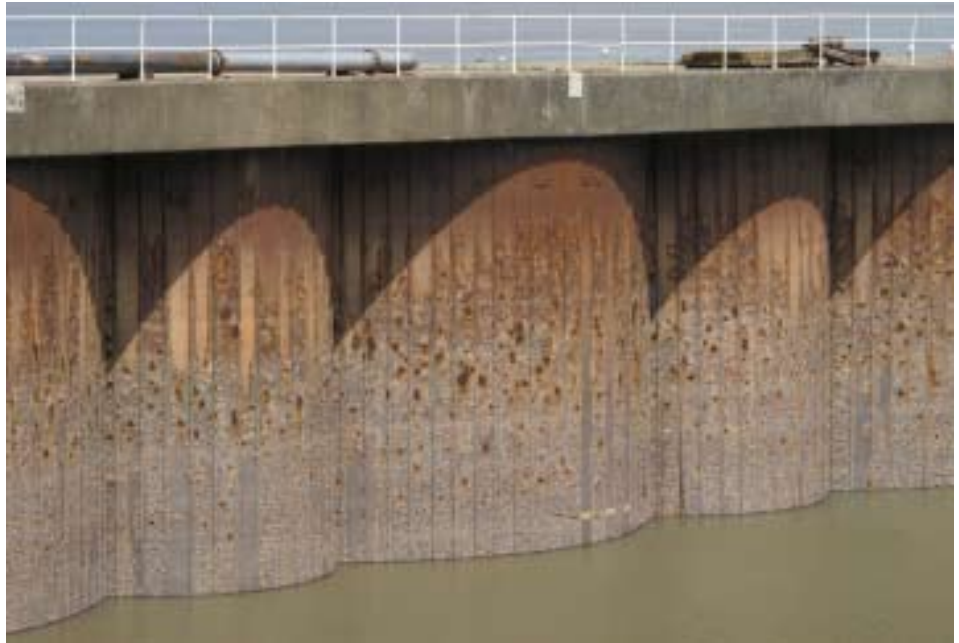
Steel piles form the cylindrical cofferdams. Between the cofferdams are additional arcs of steel piles, making much of the cofferdam piles inaccessible. Silty water conditions and fast-moving tides make visual inspection of the structure virtually impossible.

The jetty is subjected to battering by both waves and ships. The tidal range is unusually high – in excess of 12 meters difference between low and high tide. The configuration of the structure makes the cofferdam walls largely inaccessible to inspection. The portions that are exposed on the exterior of the structure are mostly underwater or within the tidal zone. In addition, the water is extremely silt-laden, making it virtually opaque.

Under these conditions, visual inspection of the underwater sections was not really possible. Some steel sampling of cell walls was done by divers. Samples were used to assess corrosion levels. Ultrasound readings were attempted as well. However, the challenges of tides and visibility made a complete assessment by this method prohibitively expensive.
